## SOLTA<sup>®</sup>LINER XTRA case study

As part of a pipeline rehabilitation under a swimming pool, at a public swimming pool in Switzerland, what is known as the **SOLTA<sup>®</sup>LINER XTRA** (2in1 Liner) of GEBR. RÖDERS AG was installed.

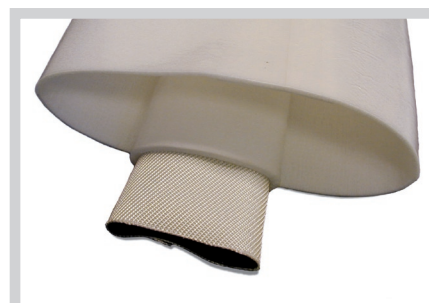
XTRA liner before rehabilitation

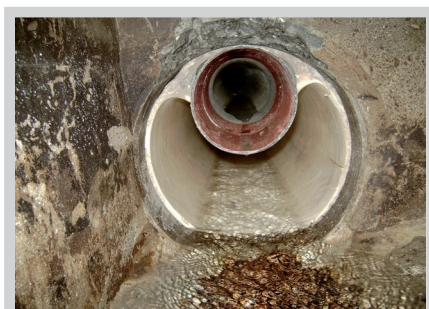
XTRA liner after rehabilitation

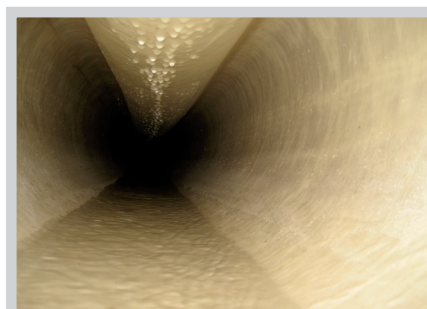
interior view of a rehabilitated XTRA liner segment

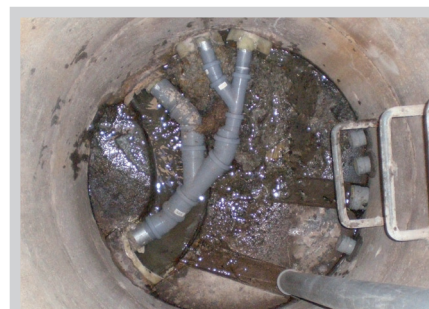
connections in manhole
